EXH. A

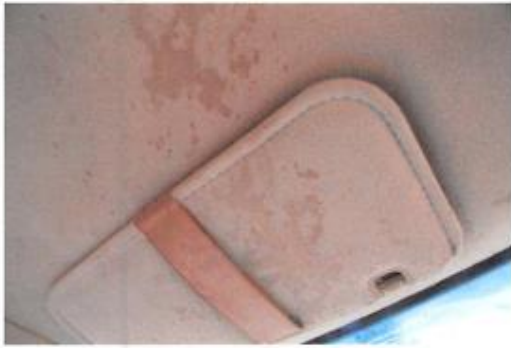
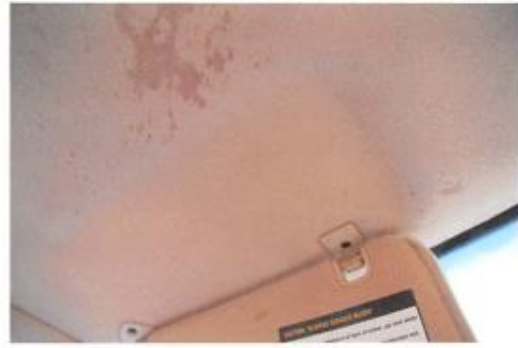
The aspersion then appears to have been projected or sprayed across the roof line towards the passenger's side. The spattered did not have the classic signs of an elongated nature to the naked eye as associated with blood and did not contain the classic tail. However, this does not rule out the possibility that the aspersion was not of a biological nature without a proper analysis.

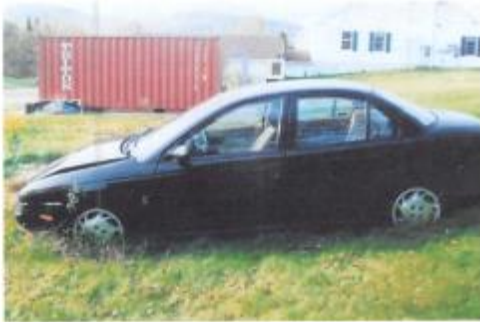
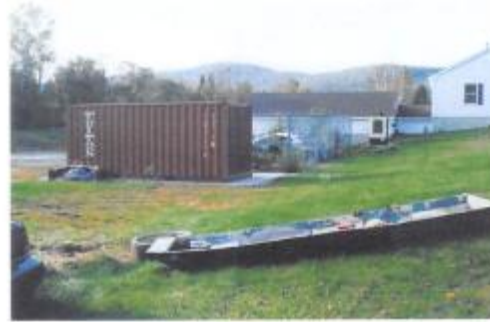
The Saturn apparently had been moved over the years from its location out in the far field as shown in the photograph below to a location adjacent to a storage bin. As shown in the photographs below, there is cross transfer of evidence pertaining to a dirt imprint on the passenger's front tire. The cross transfer would have developed when the Saturn was at rest in the field over an extended period of time before being moved. Simply moving the Saturn, now developed further damage to the front bumper which was evident.

*Possibly 2007 photographs based on computer file property*

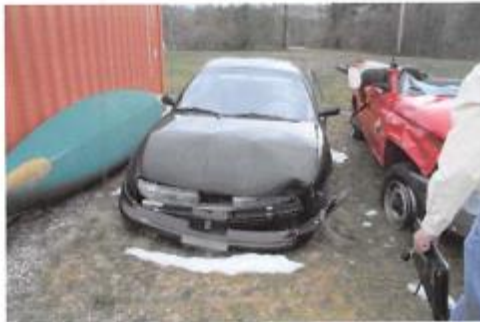
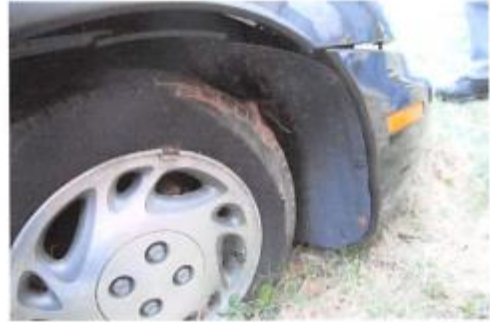
*May 1, 2010 during vehicle inspection*

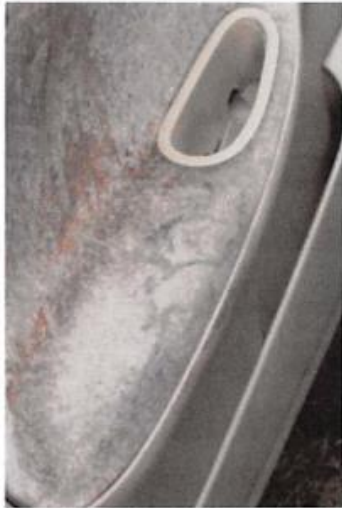
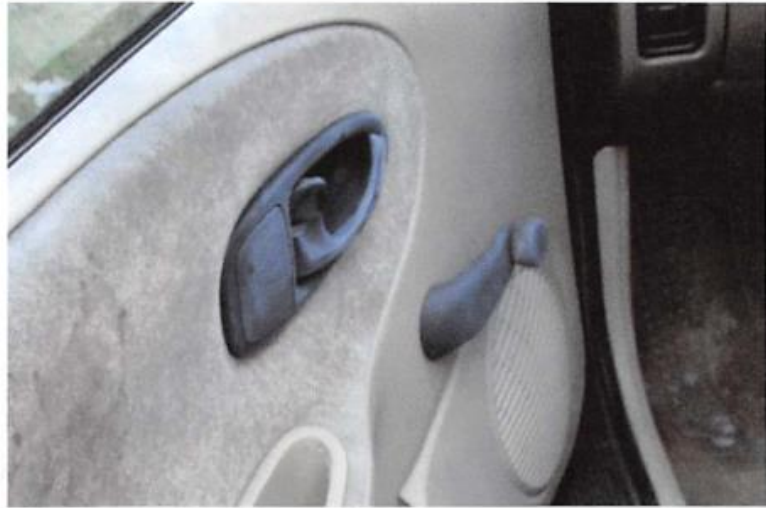
The aspersion then appears to have been projected or sprayed across the roof line towards the passenger's side. The spattered did not have the classic signs of an elongated nature to the naked eye as associated with blood and did not contain the classic tail. However, this does not rule out the possibility that the aspersion was not of a biological nature without a proper analysis.

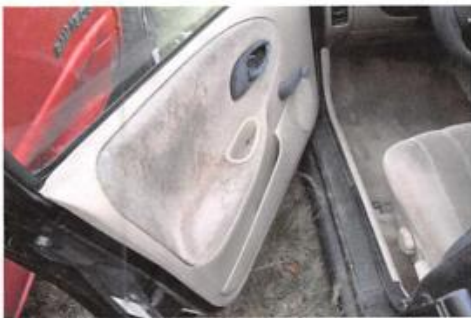
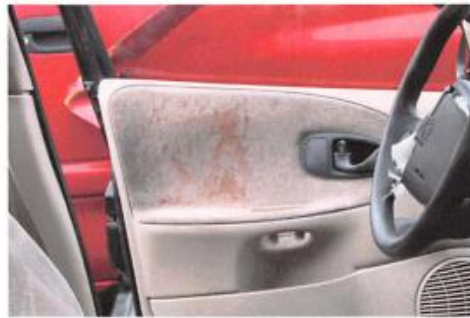
Another area containing the same type of stain was located on the driver's door panel. This area was heavily saturated and had a downward type spray. What was interesting about this area was it mainly was positioned on the aft section of the door panel with almost a vertical boarder going down the right side just aft of the interior handle. There was also no liquid aspersion on the driver's seat.
